# Commercial Roof Thermal Inspection Report

## SAMPLE REPORT

Radiometric thermal and high-resolution visual survey  
of a commercial premises, East of England

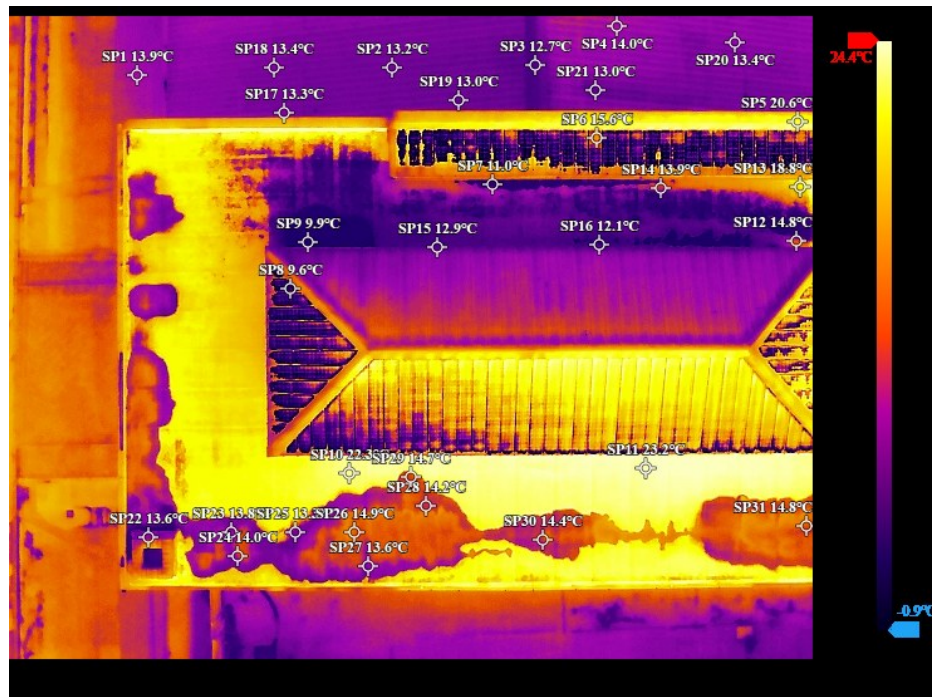
| # | Finding | Location | Severity |
|---|---|---|---|
| 1 | Moisture retention within flat roof membrane — confirmed ingress zone | Southern and western flat roof areas | High |

Irregular cold anomalies were recorded across the southern and western flat roof areas, reading **9.6–9.9°C against adjacent dry membrane at 13–14°C** — a sustained deficit of 3.5–4.5°C. The anomalies correlate precisely with dark staining visible in the paired photographs, persist across frames captured at different sun angles, and follow the pattern of the staining rather than any structure or shadow line. This is the characteristic signature of moisture retained within the roof build-up: wet substrate cools through evaporation and holds temperature through thermal mass.

**This area corresponds to the location where water ingress was reported inside the building,** and was subsequently confirmed as the ingress zone by the client's remedial contractor.

Thermal frame — annotated spot measurements. Cold anomalies (dark purple) at SP8 9.6°C and SP9 9.9°C against dry membrane at 13–14°C. Range –0.9 to 24.4°C.

| # | Action | Detail | Timeframe |
|---|---|---|---|
| 3 | <b>Monitor the affected membrane (Finding 1)</b> | Once items 1–2 are complete, allow a dry-down period and re-survey the affected area. If cold anomalies persist, localised membrane replacement over the wet substrate is likely to be required. | Within 3 months |

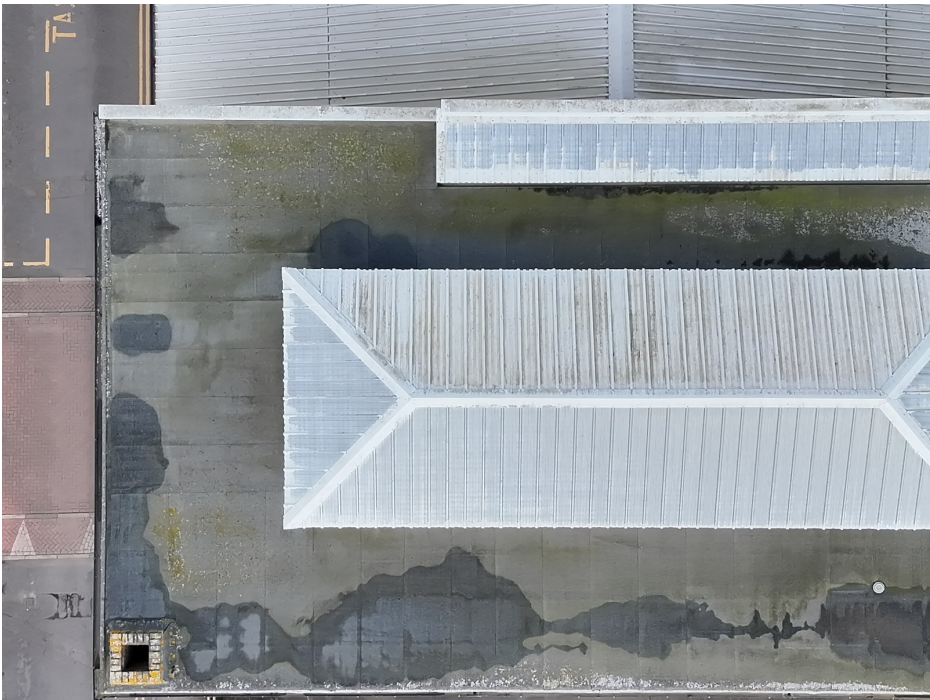
*Paired visual frame — dark moisture staining matching the thermal anomaly pattern.*

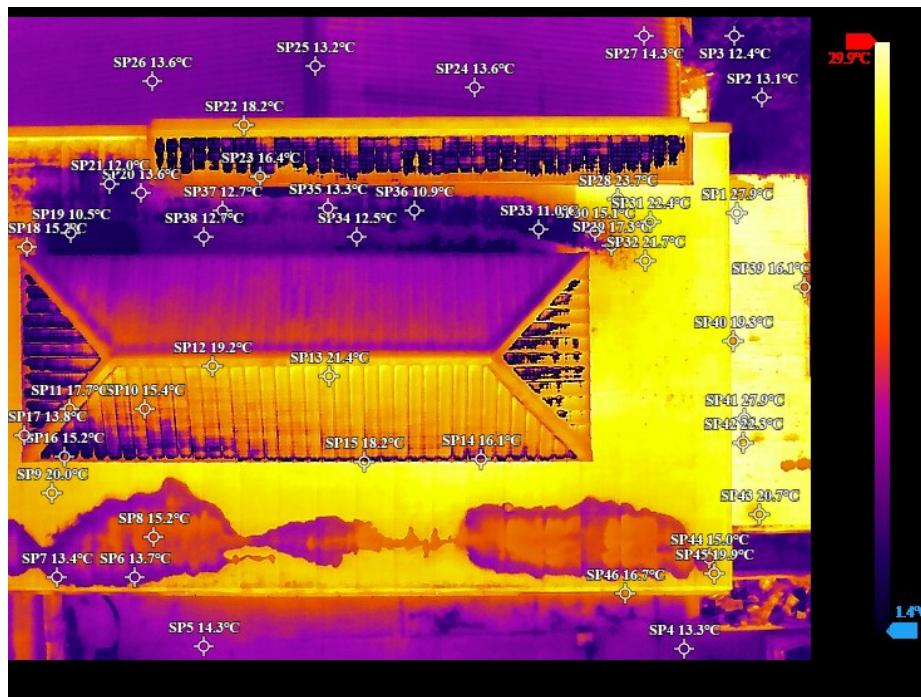
| # | Finding | Location | Severity |
|---|---|---|---|
| 2 | Impeded drainage and standing water | Northern channel between rooflights and hipped roof | Medium |

The drainage channel between the north rooflights and the hipped metal roof shows a continuous cool, damp band, with the coldest roof-surface readings of the survey recorded here (**10.5–11.0°C**). The paired photographs show moss and organic growth along the channel — physical evidence of persistent standing water and slow drainage. The single visible outlet serving this run sits within a stained zone and should be rodded and inspected.

Impeded drainage does not itself constitute ingress, but it loads the roof with standing water and feeds the moisture retention recorded in Finding 1. Clearing this drainage path is a low-cost action that directly reduces the driving head of water over the affected membrane.

Thermal frame — cold band along the northern channel (SP33 11.0°C, SP36 10.9°C, SP19 10.5°C). Bright zones at right are solar loading, not defects (see Section 6). Range 1.4 to 29.9°C.

| # | Action | Detail | Timeframe |
|---|---|---|---|
| 2 | <b>Clear and re-test the northern drainage path (Finding 2)</b> | Rod the outlet, clear organic growth from the channel, and water-test to confirm free discharge. | Priority — immediate |

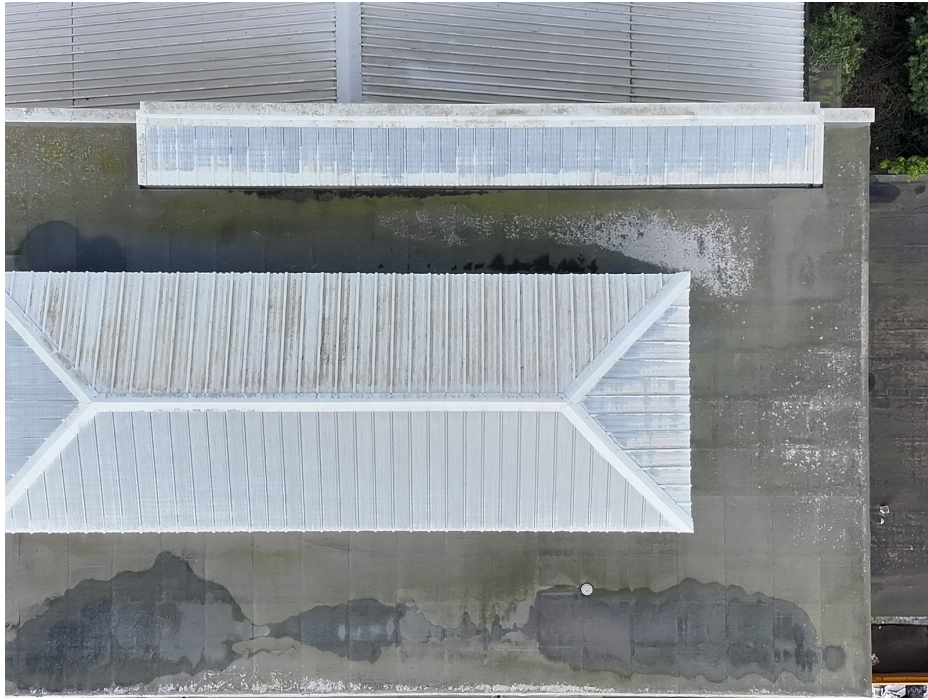
*Paired visual frame — organic growth and wet staining along the channel; outlet visible lower right within a stained zone.*

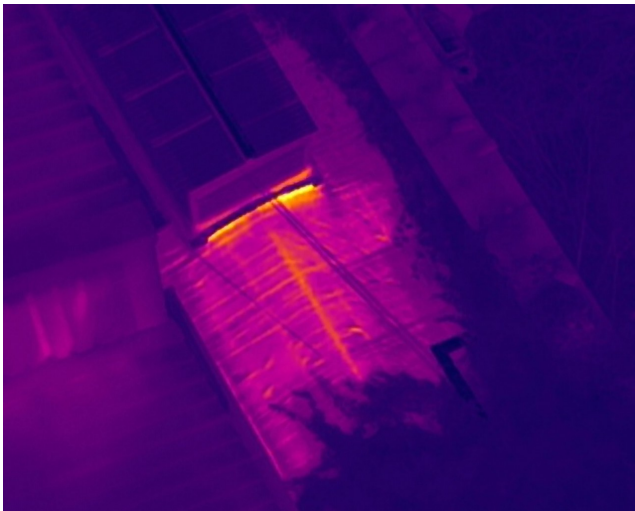
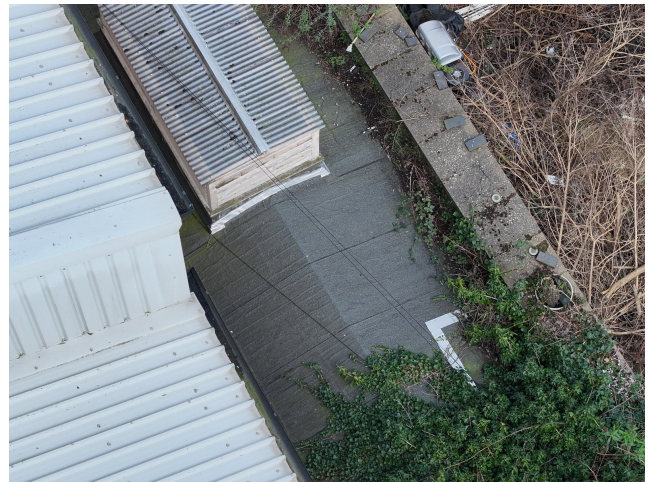
| # | Finding | Location | Severity |
|---|---|---|---|
| 3 | Heat loss and probable entry point at clerestory junction | Clerestory base, above reported ingress area | High |

An oblique detail pass over the louvred clerestory recorded a strong linear warm signature at its base, with fan-shaped warm streaking running down the surface below. This pattern is consistent with warm interior air escaping through a failed seal or flashing at the clerestory-to-roof junction. A defect of this kind is also a likely water entry route under wind-driven rain.

The junction sits directly above the area of reported internal ingress, and we assess it as the **probable entry point**, with Findings 1 and 2 representing the accumulation and retention of the water that enters here. This assessment was borne out by the remedial contractor's subsequent investigation.

Left: oblique thermal frame — linear hot signature at the clerestory base with warm streaking below (heat escaping the building envelope). Right: paired visual of the junction area.

| # | Action | Detail | Timeframe |
|---|---|---|---|
| 1 | <b>Reinstate the clerestory junction seal (Finding 3)</b> | Engage a roofing contractor to open up, inspect and re-seal the clerestory base flashing. This closes the probable entry point. | Priority — immediate |

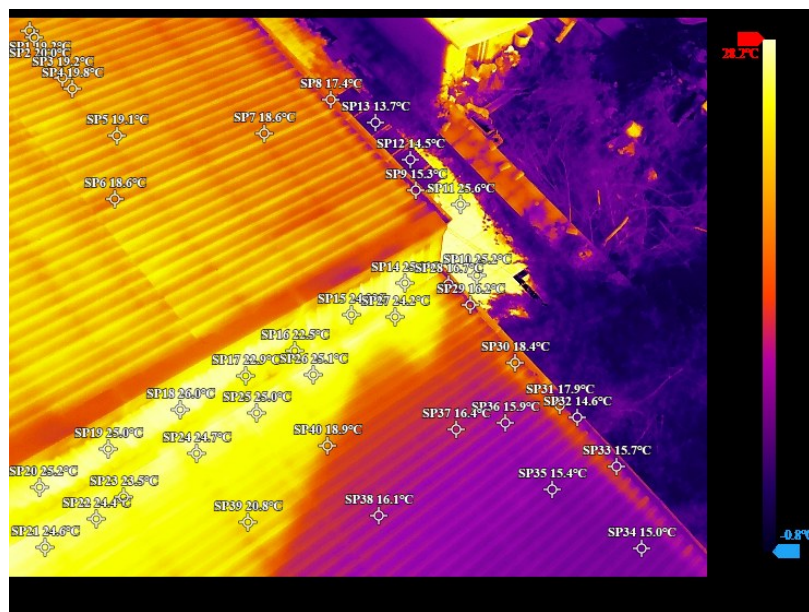
**Solar loading.** The survey was flown in late morning with intermittent bright sun. Sunlit surfaces read up to 10°C warmer than identical shaded surfaces (e.g. 25°C vs 15°C either side of a shadow line on the pitched roof). These warm zones follow sun angle, not construction, and are excluded.

Solar loading example — the sharp 25°C / 15°C split on this pitched roof follows the shadow line, not the construction. Correctly identifying non-defects prevents unnecessary remedial spend.
